SediCon Sluicer for Miwa Dam, Japan

SediCon provided a full scale Sluicer for test and demonstration at Miwa Dam.

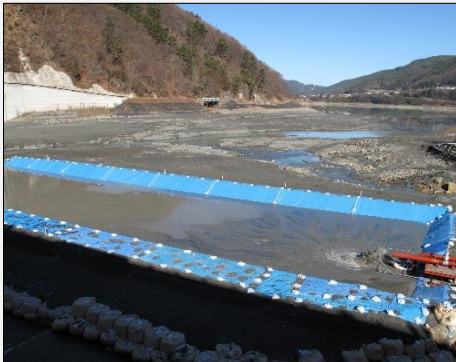
Outlet area

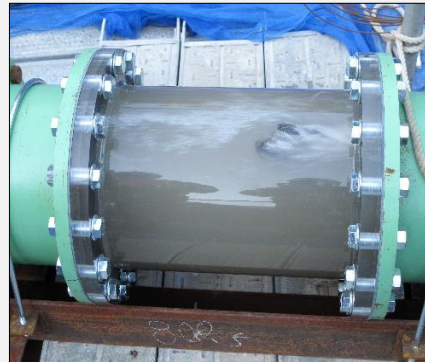
Water with sediments

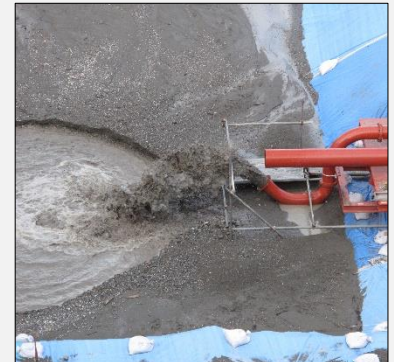
Discharge of sediments

During the test 1.200 m³ sediments were discharged downstream of the dam by opening the outlet valve. The successful test verifies that the SediCon Sluicer is a suitable system for sediment removal.
